A Performance Improvement Programme

Massimo Stori – Cantiere Navale Vittoria - Italy
(massimostori@vittoria.biz)

Abstract

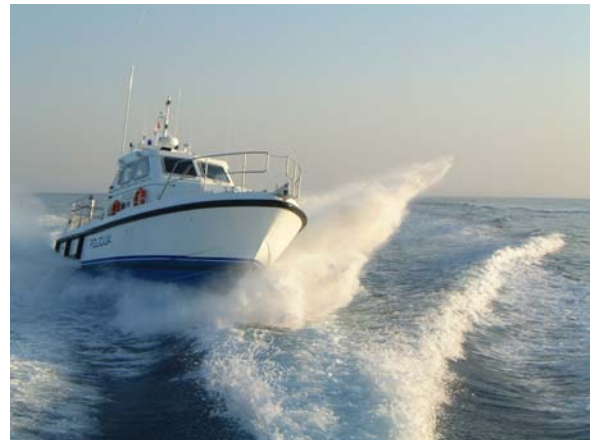
The boat under investigation (see picture) is one of a class of three FPB's with the following main characteristics :

Length over all	m	13,67
Beam	m	4,20
Mean draft	m	0,86
Displacement	t	15,310
Propulsion engines (2)		Cummins
WOT power	Kw	492
WOT revolutions	r.p.m.	2.300
Reduction gear ratio		1:1,581
Propellers (2)		Eliche Radice
Number of blades	n.	4
Diameter	m	0,630
Pitch	m	0,930
P/D		1,48
Design speed	knots	32

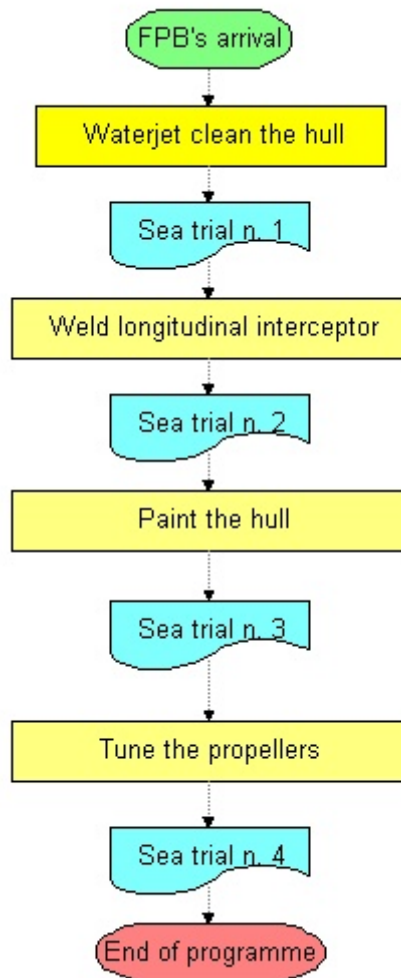
Figure 2 – Programme flow chart

The Shipyard made a proposal, which was accepted by the Shipowner, to apply measures both to reduce the hull resistance and increase the propeller efficiency, quantifying their effects. During the period spent at the Shipyard the hull was scheduled to be painted. The list of the jobs is summarized in the flow chart of Figure 2 :

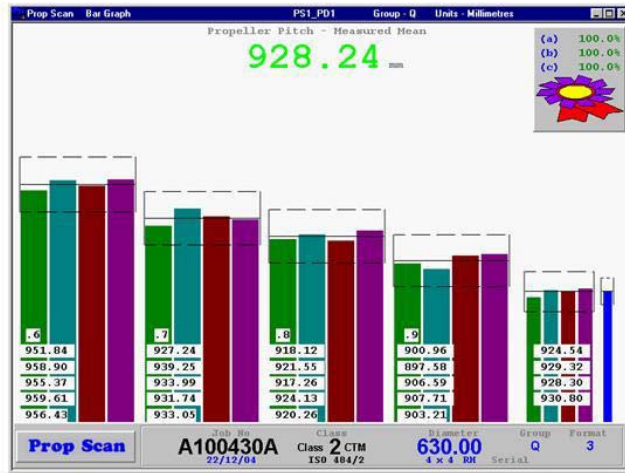
Figure 3 – Right handed propeller pitch measurements

Diametre	630
Pas	928
Rotation	RH
Class ISO	2

Each figure shows four histograms with four vertical bars representing the measured pitch at four different radii of the propeller (0,6 – 0,7 – 0,8 – 0,9) and for each of the four blades. The smaller histogram on the right represents the mean pitch at each of the four radii. The green number on the center top of the figure is the mean propeller pitch. It can be seen that the right handed propeller was in ISO Class 2, while the left handed propeller was found to be ISO Class 1.

The propellers have been tuned to reach both an ISO Class 1 tolerance. The measured pitch after the tuning is given in Figures 5 and 6.

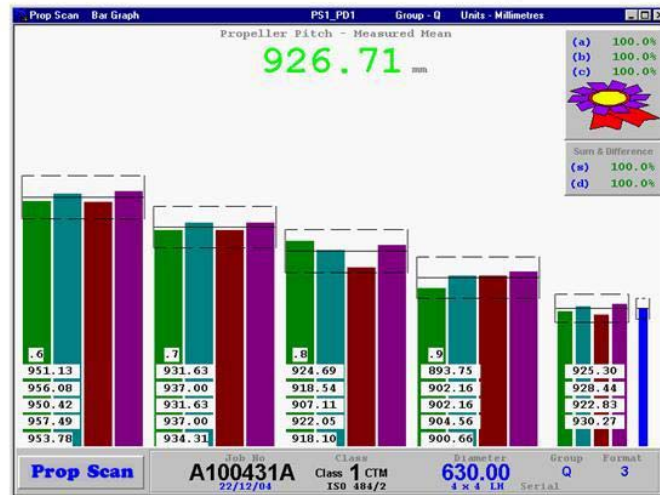
Figure 4 – Left handed propeller pitch measurements

Diametre	630
Pas	926
Rotation	LH
Class ISO	1

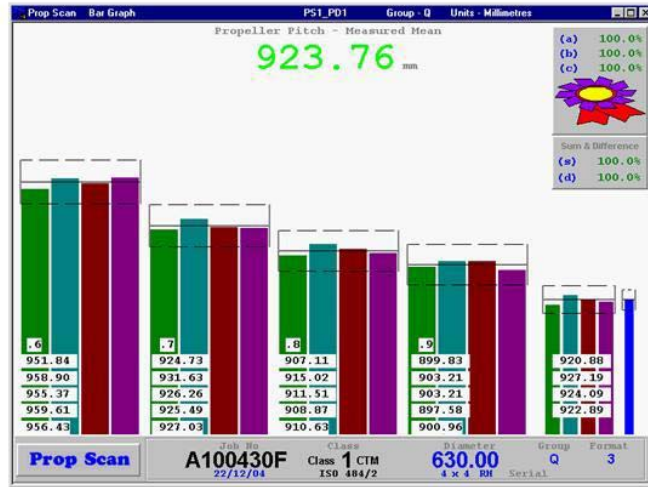
Figure 5 – Right handed propeller pitch measurements after tuning

Diametre	630
Pas	923
Rotation	RH
Class ISO	1

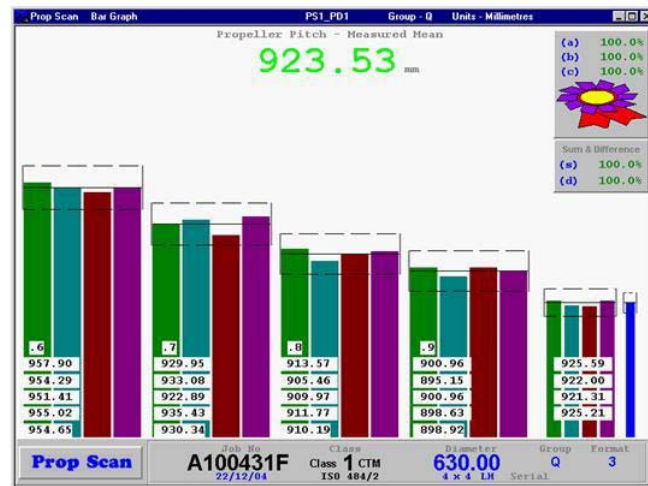
Figure 7 – Left handed propeller pitch measurements after tuning

Diametre	630
Pas	923
Rotation	LH
Class ISO	1

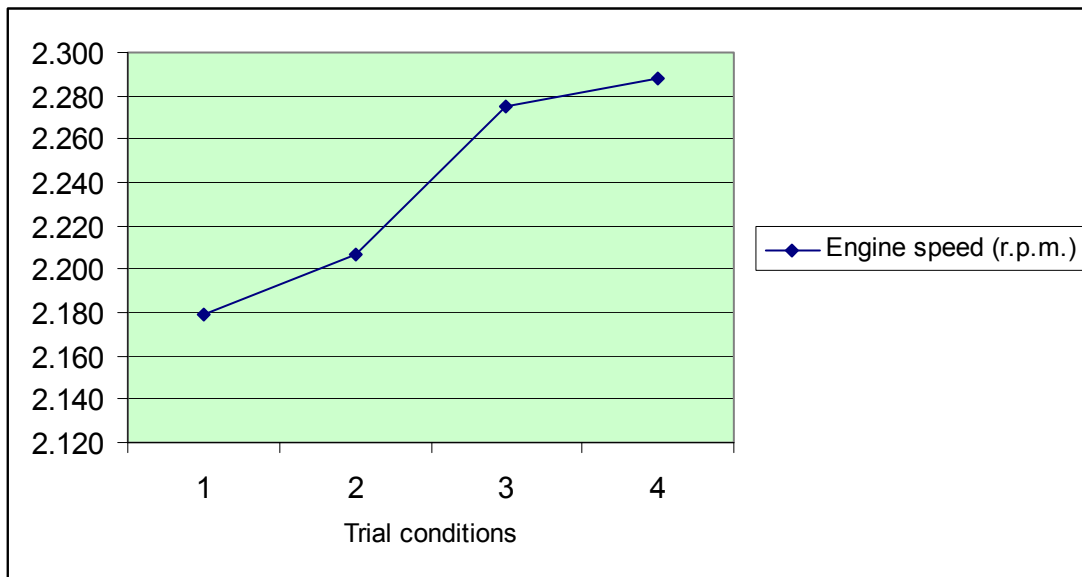
Figure 8 – Engine speed increase

The speed of the engine was 2,178 rpm at arrival, some 120 rpm below nominal speed, and 2.283 rpm at departure, very close to the nominal speed of 2.300 rpm.

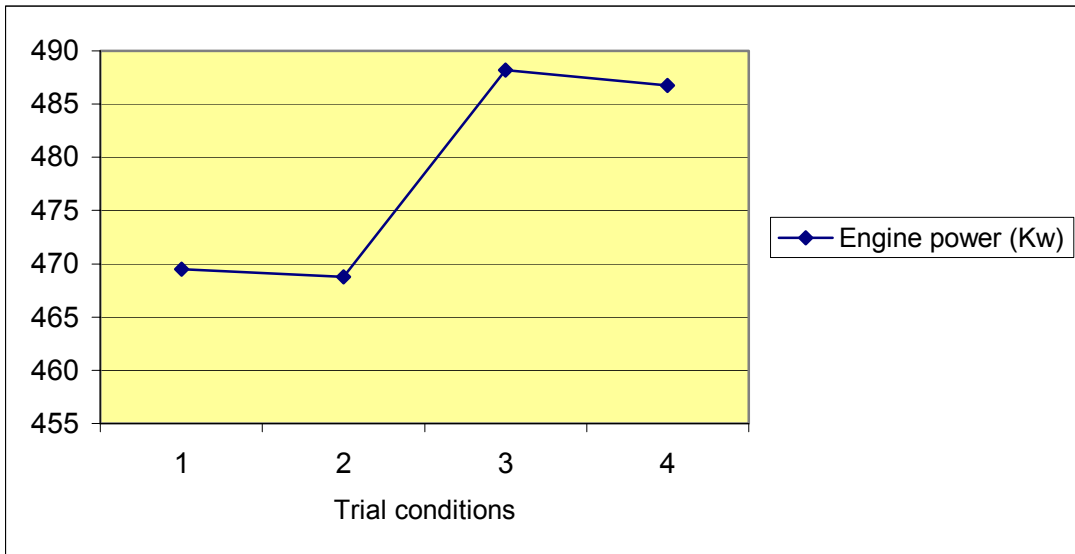
Figure 9 – Engine power

The power delivered by the engines was 488 Kw at departure. Considering the loss in the reduction gear (the torsionmeter was positioned on the propeller shaft) this is slightly more than nominal power. Such optimum condition were reached by a small pitch reduction during propeller tuning.

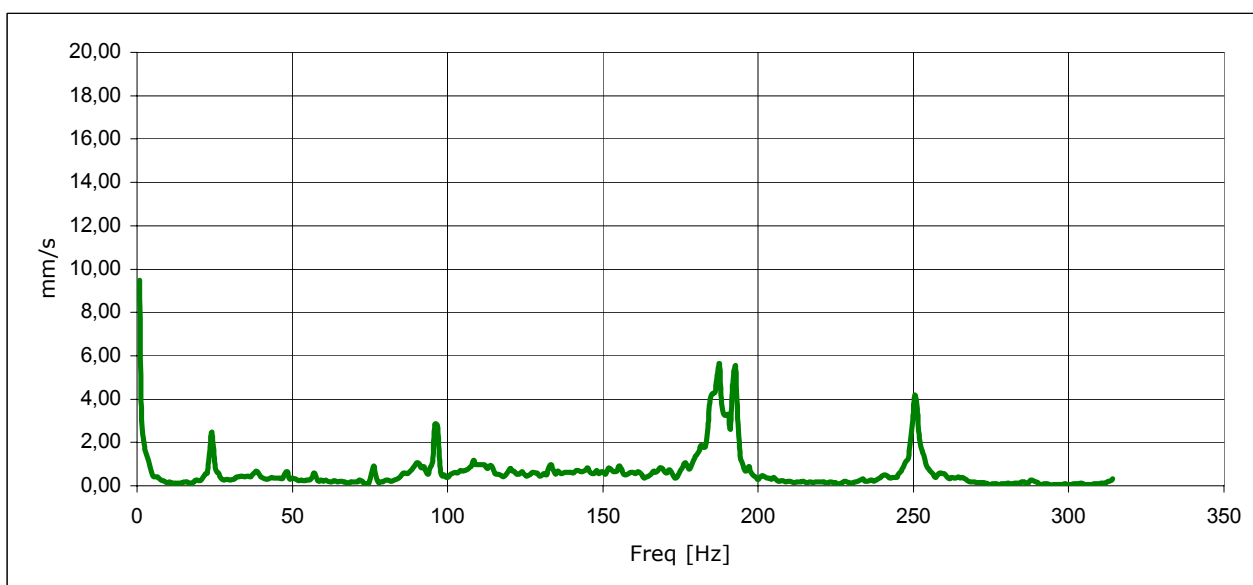
Fig. 10 and Fig. 11 show the frequency analysis of vibration data for the propeller before and after tuning. It can be seen that a sharp decrease in vibrations can be observed at the frequency around 190 hz (two times blade frequency). Numerical values are given in Table 5.

Fig. 11 – Frequency analysis at WOT **after** tuning (shafts' mean rpm = 1.444)

Finally a moderate propeller tuning has allowed a speed increase with less power and higher engine speed. Tuning of the propellers had a good effect on vibration reduction at full speed operations. This can result in longer service of shafts bearings and seal.
